Radon Survey Analysis Job #20-C149R

Harney County School District
ESD Regional Service Center
c/o Responsible Party

property located at
25 Fairview Heights
Burns, OR 97220

December 22, 2020

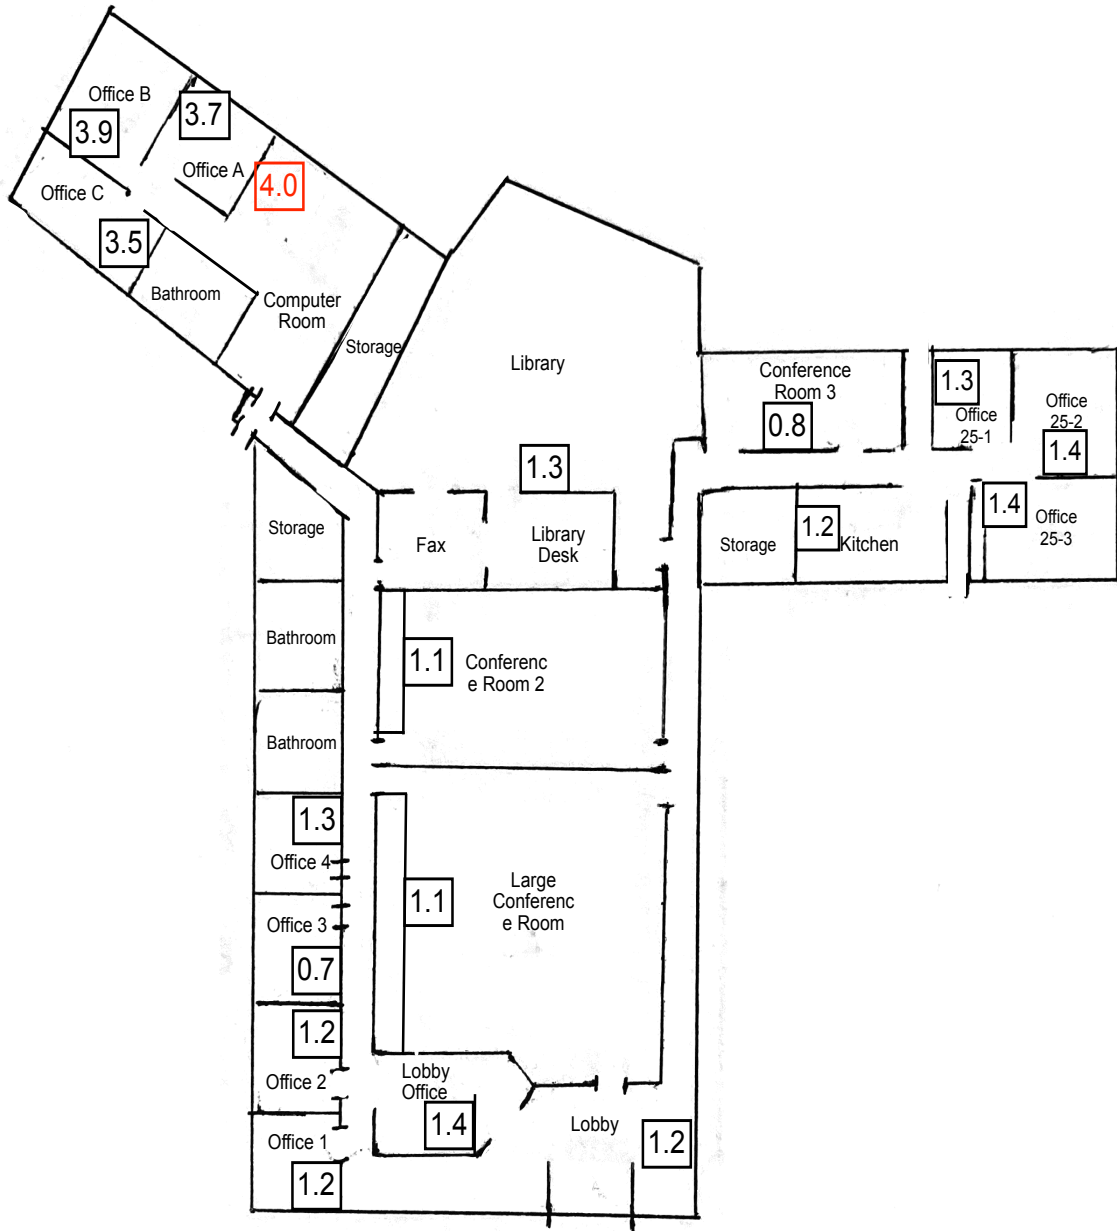
Appendix A: Map of Test Results – ESD Building

Test was a “Short-Term” test, with minimum duration of 60 hours. See the chart below of areas in buildings that were tested, and the corresponding levels found. Maps of the test levels are provided in Appendix A. Note that one(1) out of eighteen(18) locations tested had results above the USEPA Action Level of 4.0 pCi/L.

It is recommended that a certified radon mitigation company be contacted to evaluate the areas which are elevated to determine appropriate mitigation action to bring them below the USEPA Action Level.
